# Hydrocyclone Repair vs Replacement

31-in-1 hydrocyclone bundles were installed in vessels on a platform in the North Sea. The Hydrocyclone bundles are periodically removed and inspected due to high solids production and erosion of the hydrocyclones. The 31-in-1 bundle is dismantled, inspected and any eroded hydrocyclones replaced with new, before the bundle is reassembled for re-installation in the vessel.

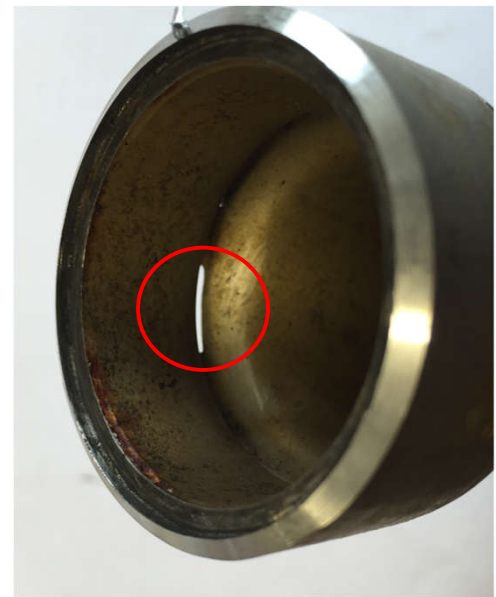
*Split hydrocyclone with erosion at the top of the taper section only*

EnSep split the liners around one of the circumferential welds so that an internal inspection of the liner could be completed. This showed that the majority of the taper sections were in good condition and the erosion was only at the start of the taper section see photo. This meant that we could offer the Client a low cost option of removing the top couple of inches of the taper section and replacing with a new 'egg cup' insert before rewelding to make the liner good. This gave the Client a further 55% price saving on the EnSep new liner price.

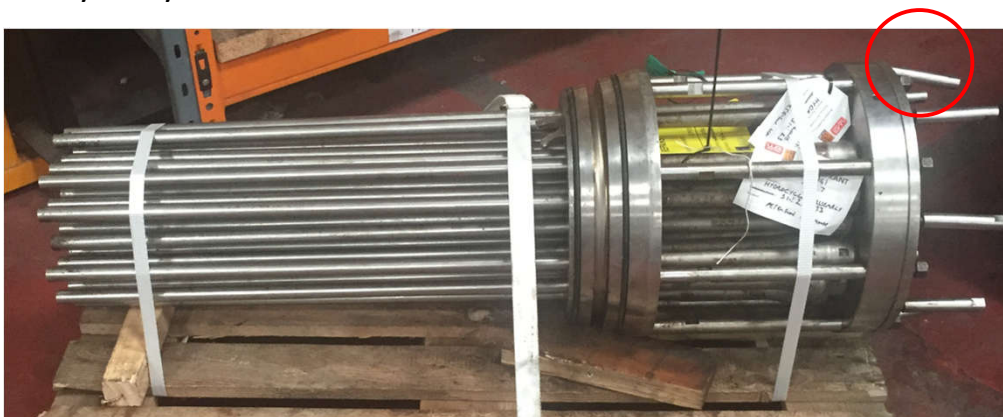
*31-in-1 hydrocyclone received by EnSep ready for inspection and repair.  
Note damage to locating lugs circled*

Ensep were instructed to make the hydrocyclone liner repairs and to replace some of the locating lugs that had been damaged. The 31-in-1 bundled was then reassembled with a new set of soft parts and returned to the Client ready for installation back in the vessel.

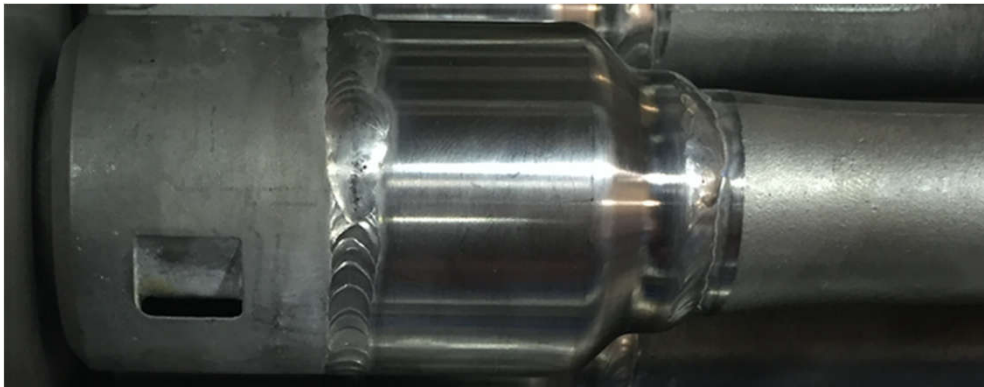
*Hydrocyclone Liner with 'egg cup' Section Repair*
